CALIFORNIA DIVISION OF MINES AND GEOLOGY  
FAULT EVALUATION REPORT FER-230  
**SUPPLEMENT No. 1**

**EUREKA PEAK AND RELATED FAULTS**  
San Bernardino and Riverside Counties, California

by  
Jerome A. Treiman  
May 20, 1993

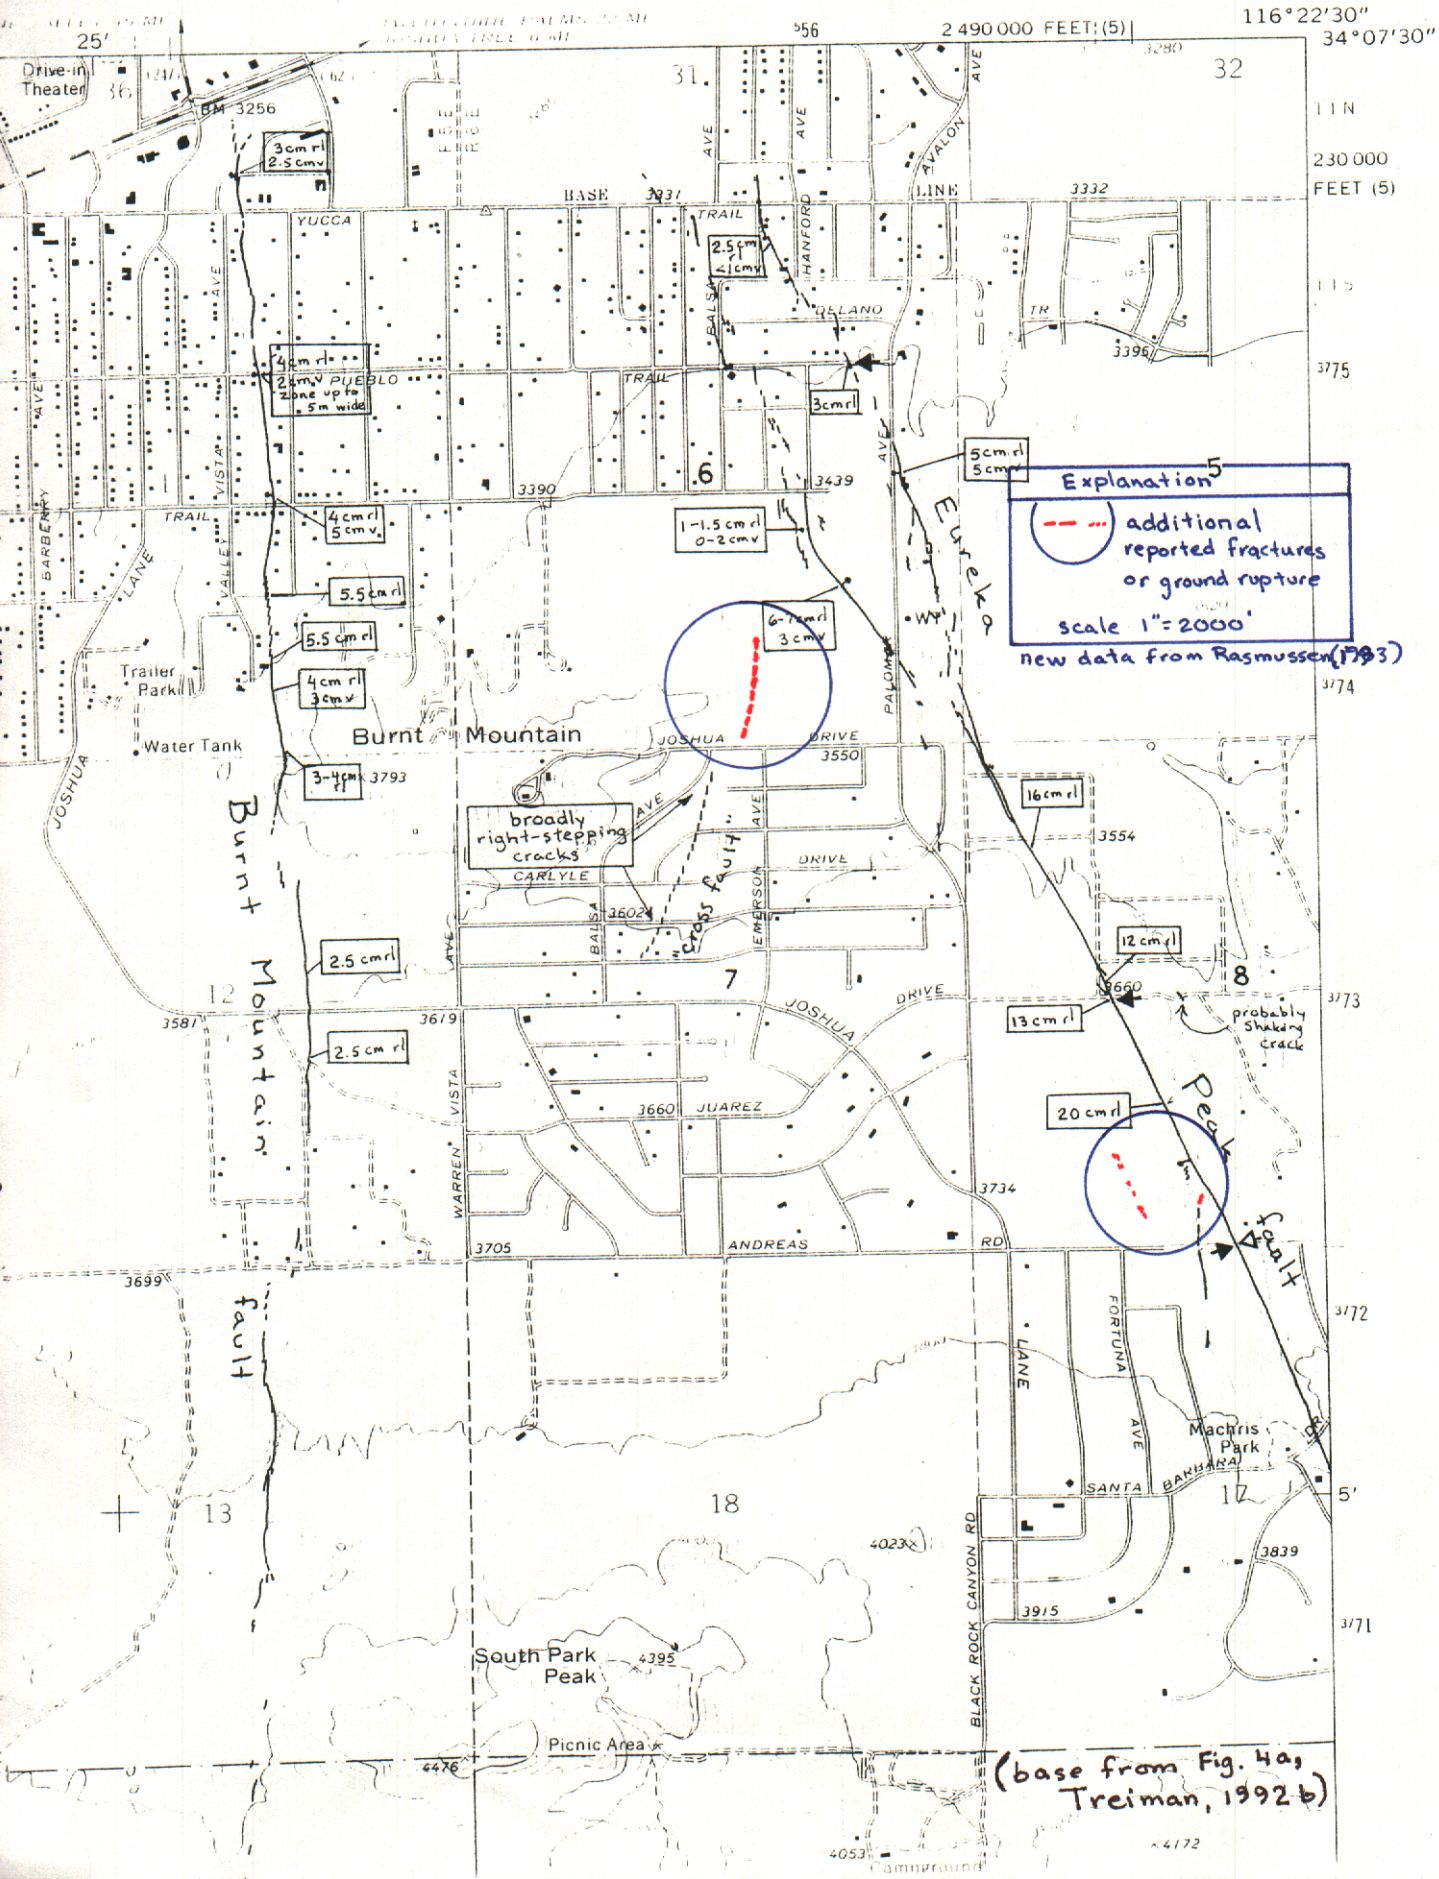
Figure 1 (FER-230, supplement)

Mapping by Rasmussen & Associates (1993) within the Yucca Valley South quadrangle shows that rupture along the "cross fault" within section 7 (T1S,R6E) extended further north than previously recognized, extending beyond the proposed Special Studies Zone (CDMG, 1993). They mapped an additional 1200 feet of discontinuous right-stepping fractures (Figure 1). This fault zone was not visible in their trenches about 250' to the north. They have also observed a weakly defined zone of discontinuous fractures to the southeast, parallel to the Eureka Peak fault (Figure 1). They could not see any measurable offset. This 1000' long set of fractures lies entirely outside of the zone proposed on the Preliminary Special Studies Zone map (CDMG, 1993) and was not visible beyond the area noted. The longest of the 10 cracks depicted (Rasmussen & Associates, 1993) were less than 30 feet long and most were less than 20 feet long.

The fractures in the SW¼ of section 8, adjacent to the Eureka Peak fault Special Studies Zone, are not as continuous or as consistent as other features which have been zoned and are not prominent enough to be visible in post-earthquake aerial photography. There was no indication of displacement and they are not clearly defined as fault features.

The cracks in the Yucca Valley airport area, although clearly related to the earthquake shaking, cannot be clearly identified as fault rupture. The features were scattered over a broad area (up to 1400' wide), were discontinuous and had no clear sense of displacement or pattern. Many of the interpreted or reported features have not been verified. Although some of the features may have been related to displacement at depth, other cracks were more clearly related to lurching. This area overlies the trend of the aftershock zone and the scattered ground-cracking was probably due to severe shaking of poorly consolidated sediments above this zone.

additional  
ground cracks  
reported by  
Rasmussen (1993)

zone of ground cracks observed after earthquake.

The other fractures noted (near the airport and in the SW¼ of section 8) should not be zoned at this time. They are not sufficiently identified with faulting such that they represent a clear risk of repeatable ground rupture.

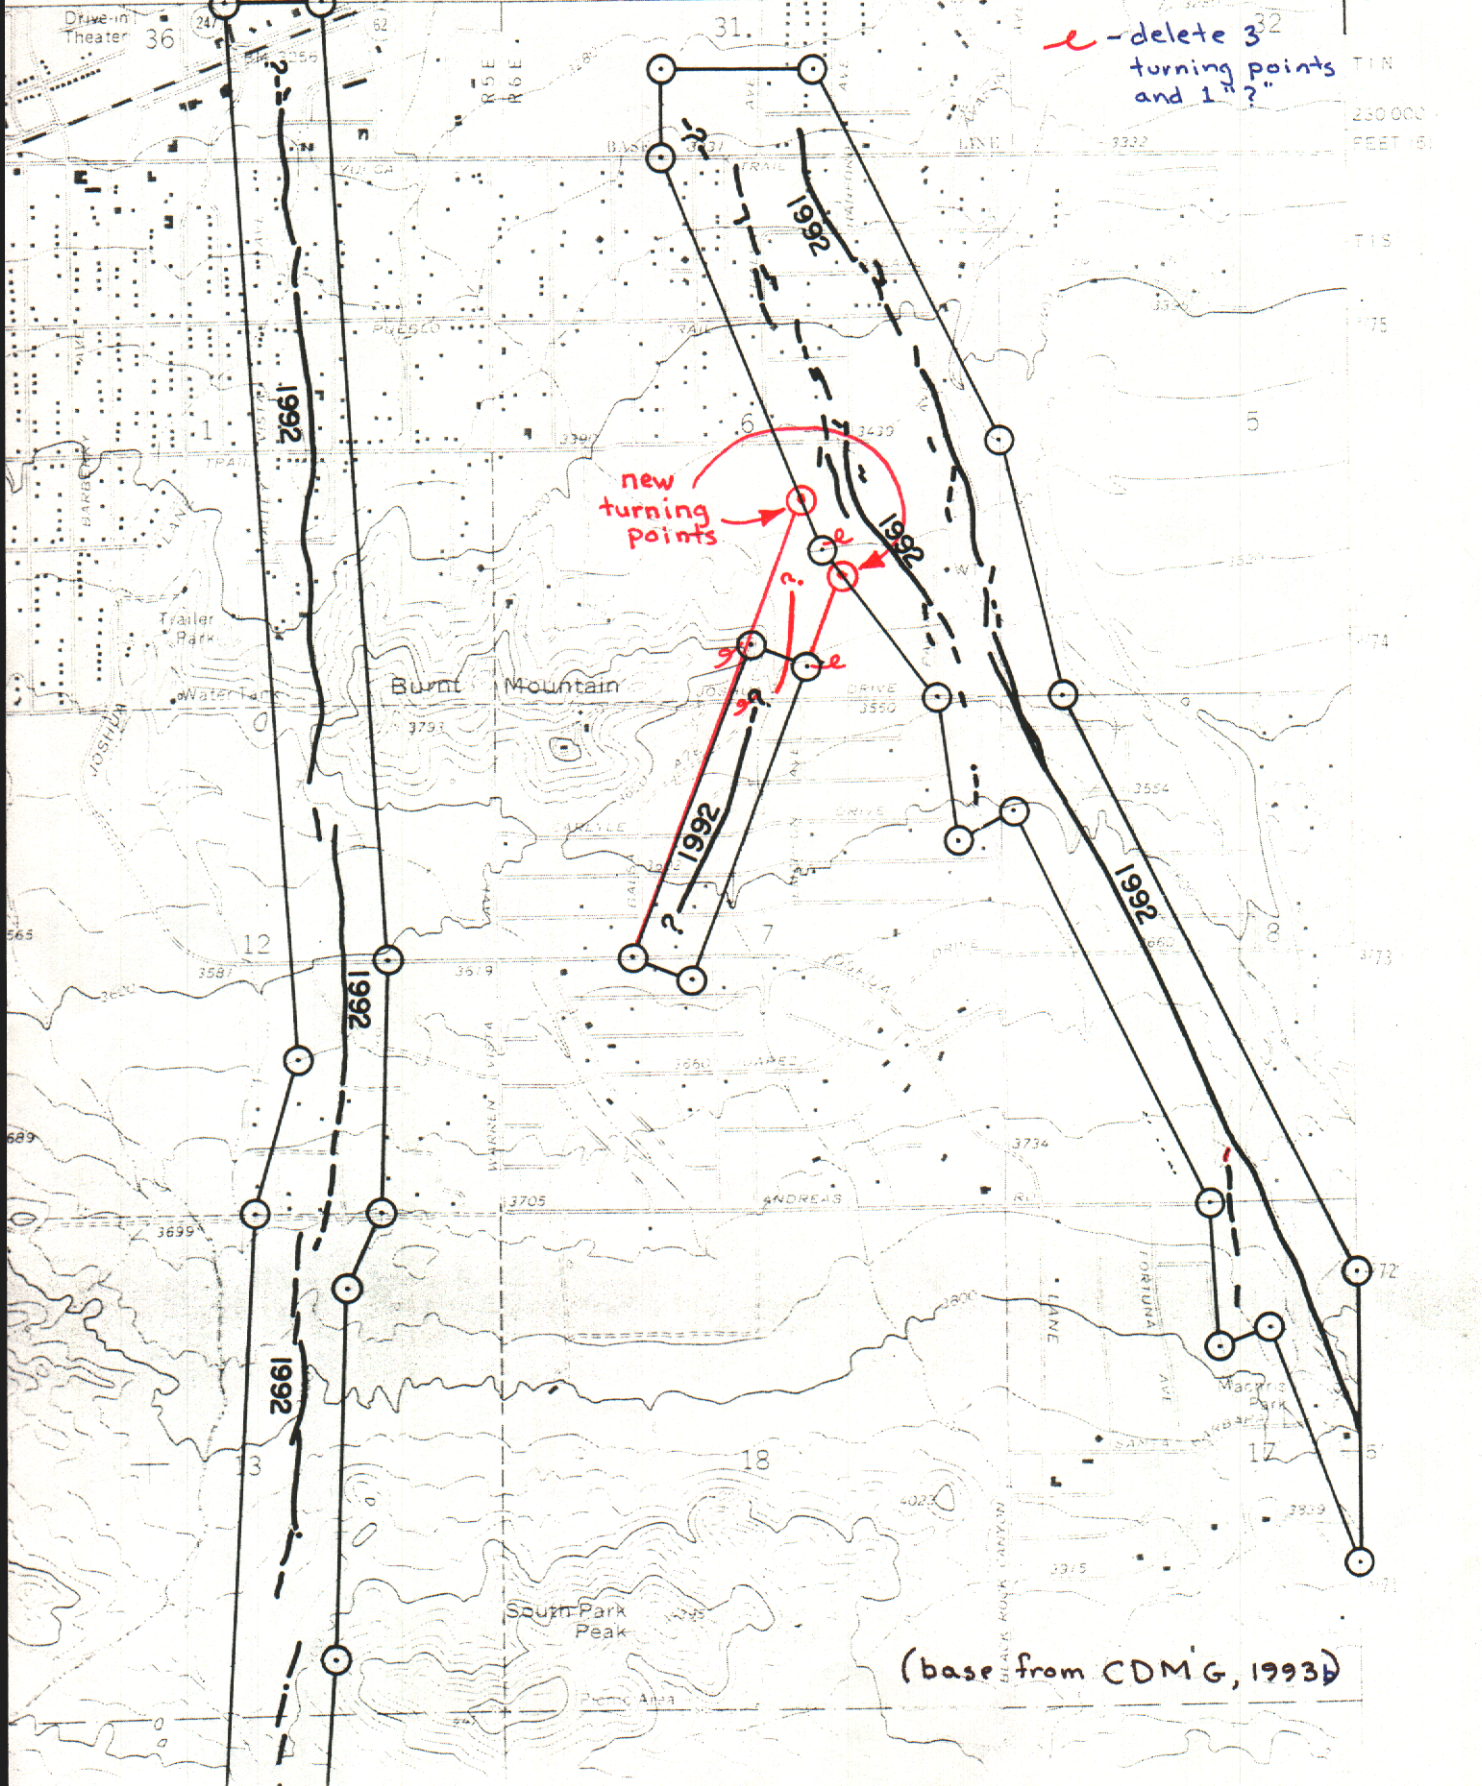
Figure 3 (FER-230, supplement)

The fractures mapped north of the "cross fault" extend a well-defined structure that is characterized by broadly right-stepping *en echelon* fractures with minor but consistent left-lateral offset.

Recommended changes  
to proposed Special Studies  
Zones.

The northern extension of the cross fault should be added to the Special Studies Zone map for the Yucca Valley South quadrangle and the zone should be modified as shown on Figure 3. The small fault zone near Avalon and Highway 62, on the Yucca Valley North quadrangle, should be included in a Special Studies Zone as indicated on Figure 4.

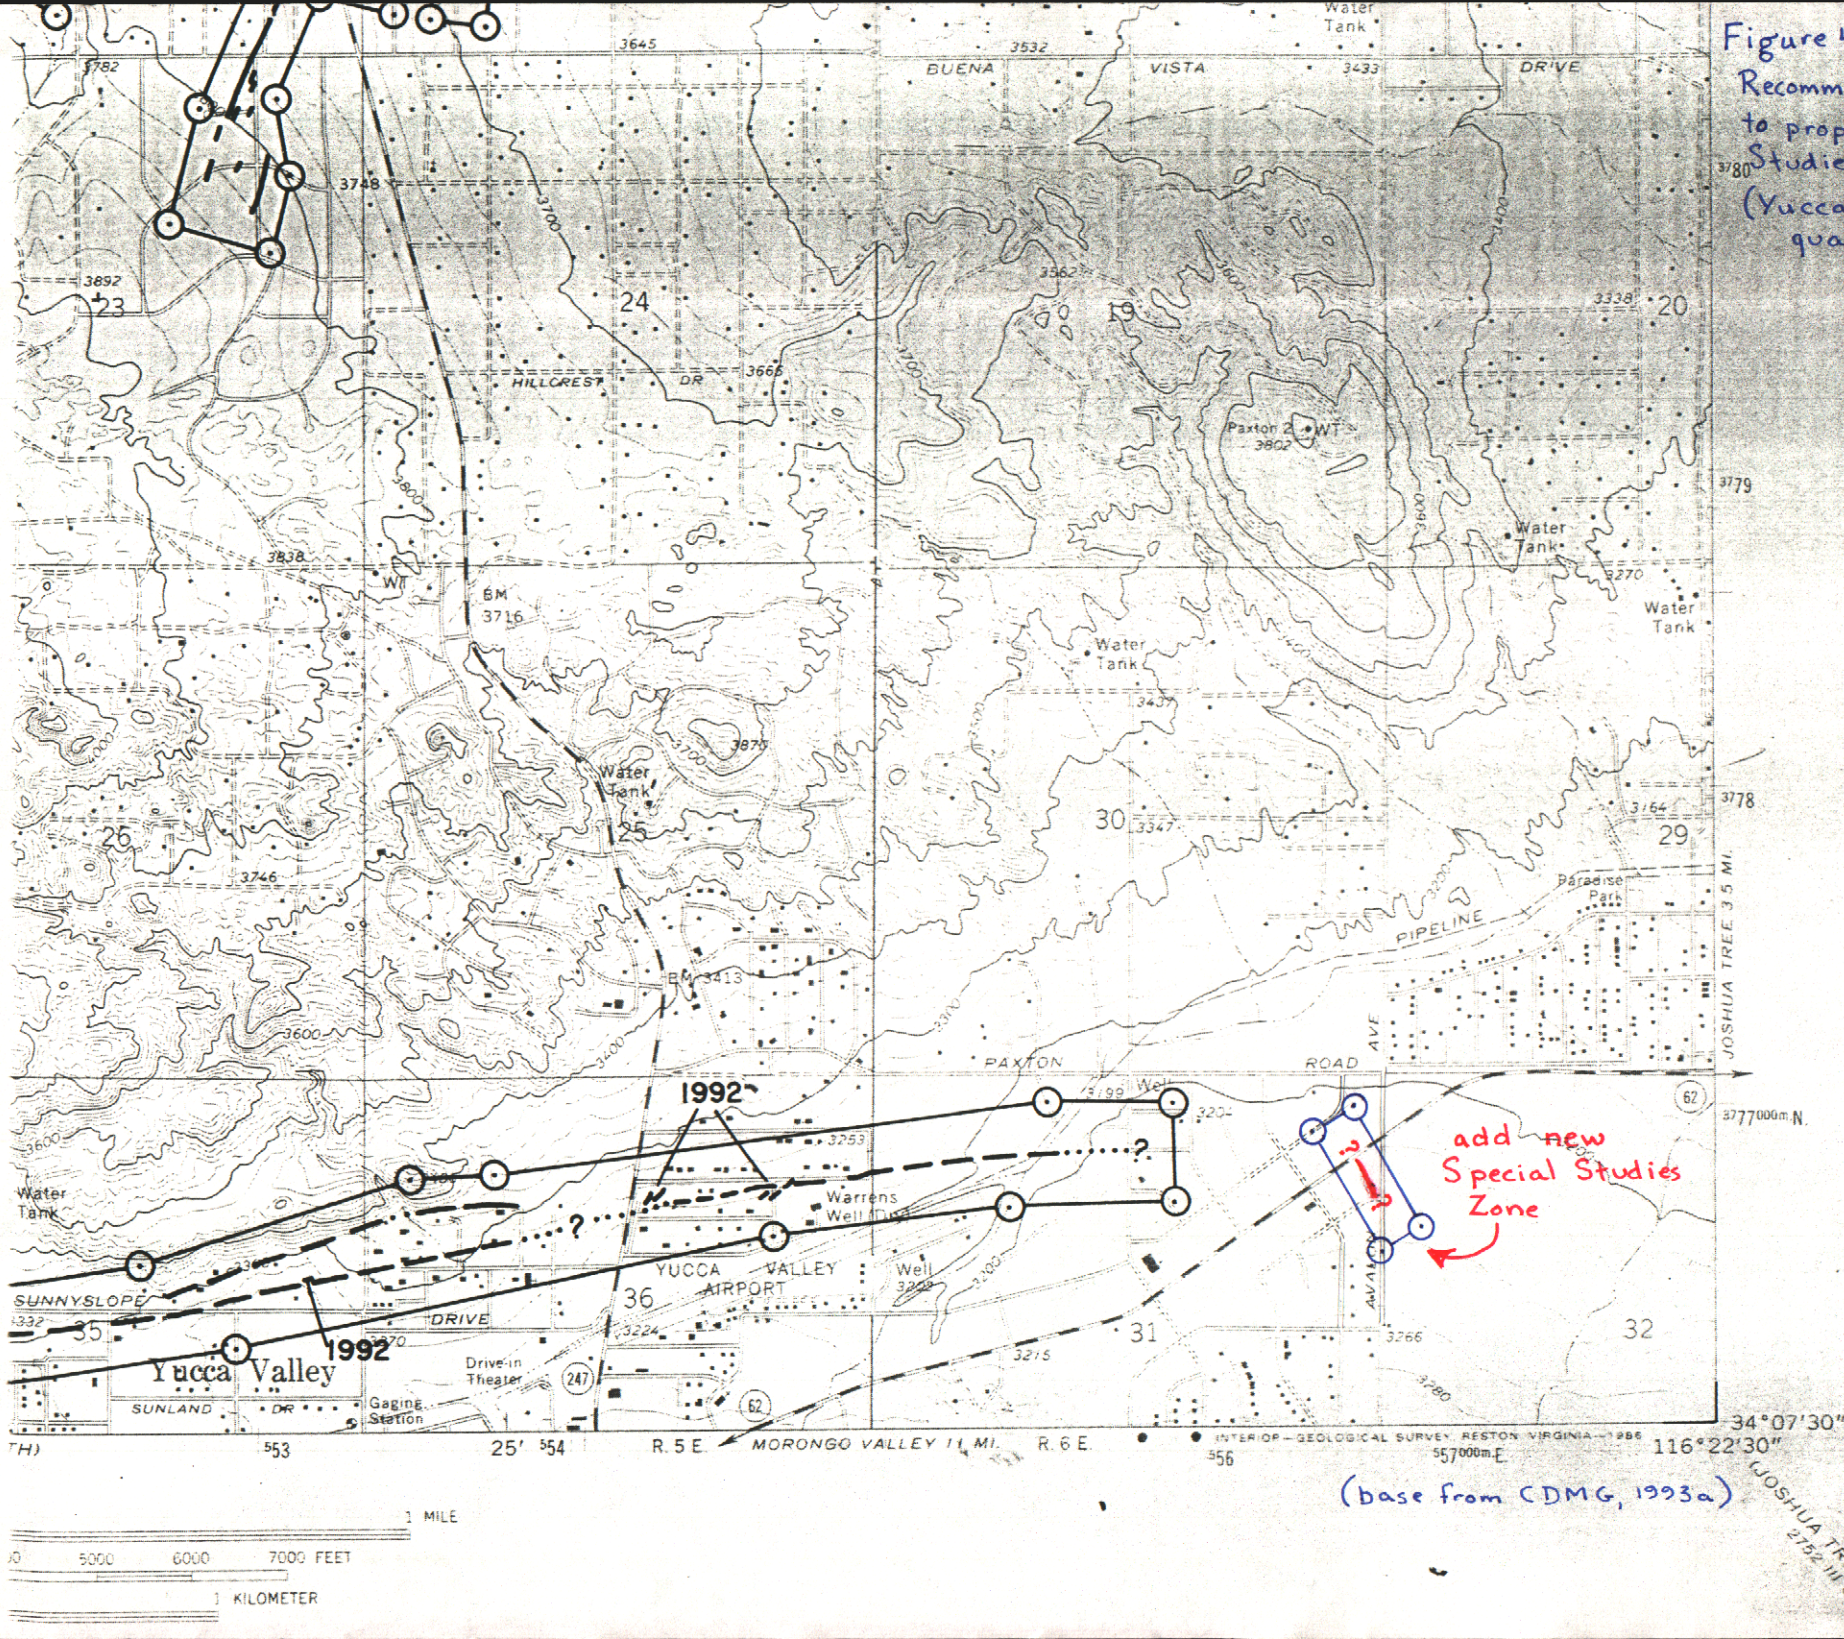
Figure 4 (FER-230, suppl.)  
 Recommended changes  
 to proposed Special  
 Studies Zones.  
 (Yucca Valley North  
 quadrangle)

The zone of cracks near Avalon and Highway 62 (Yucca Valley North quadrangle), is well defined. Although this short fracture set is isolated and is not clearly related to any of the better defined fault rupture, the distinct left-stepping pattern is strongly suggestive of right-lateral shear.
